Restoring the Mosaics of San Vitale**

The VI century Basilica of San Vitale in Ravenna is a unique example of Byzantine art and culture. In recent times an important conservation project has restored the basilica's mosaic wall decorations to their full glory. Livia Alberti was one of the leaders of the restoration team.

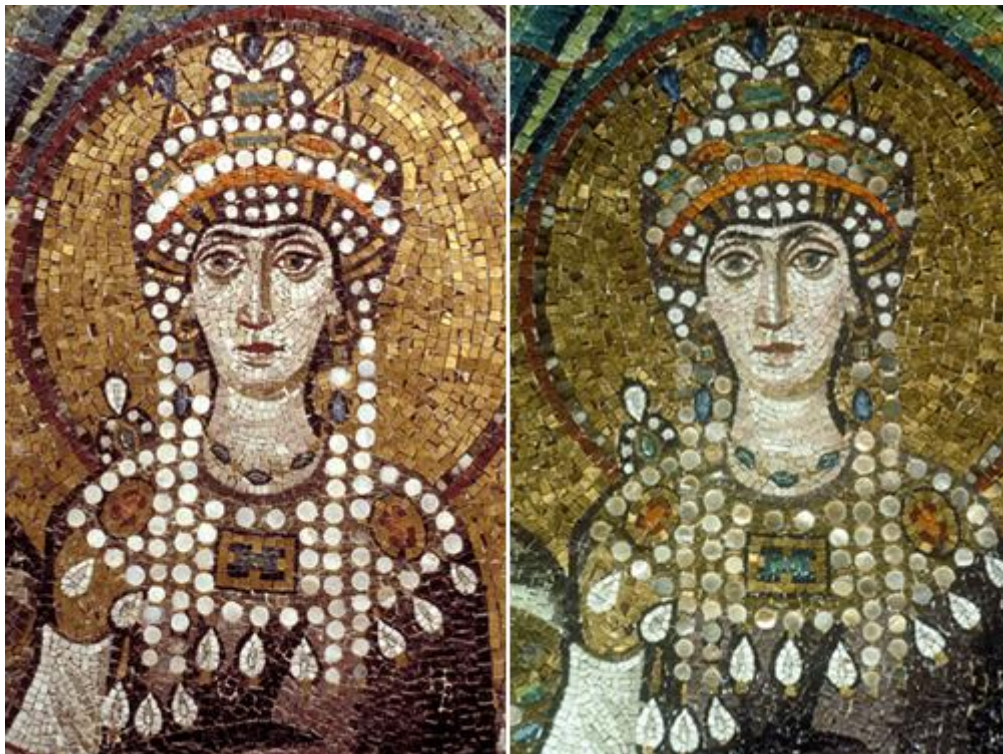
Head of Theodora before and after cleaning. This involved the removal of a layer of calcium carbonate which had re-crystallized on the surface of the mother of pearl. Photo by Livia Alberti

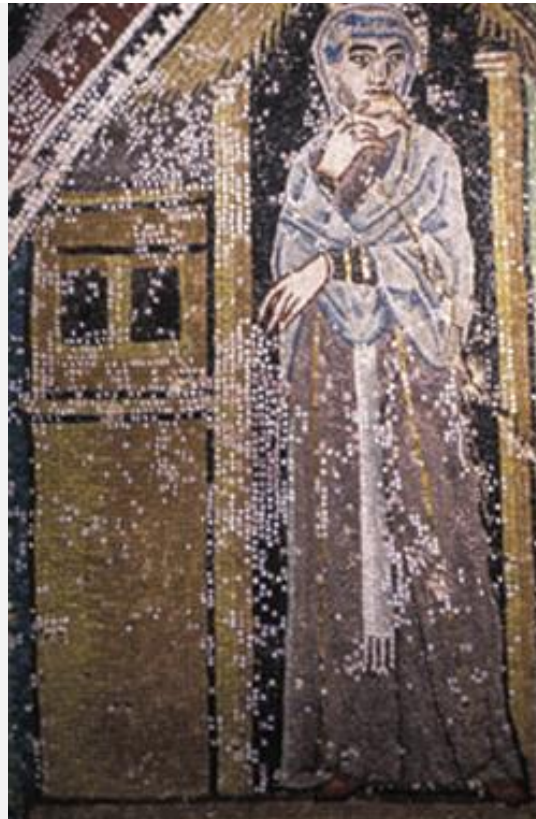
Sara in the scene of the sacrifice of Isaac. Adhesive paper used to indicate mobile tesserae: those with a red dot indicated falling tesserae, plain white showed those not completely adhered. Photo Livia Alberti *

One of the first steps was to determine which tesserae were loose or not firmly bedded. This we did by touching every single tessera and marking those which needed consolidation with bits of adhesive paper. The detached tesserae were re-bedded with hydraulic mortar and the moving ones were re-adhered by syringing an acrylic resin in behind them, taking care to maintain the original orientation and position of each one.

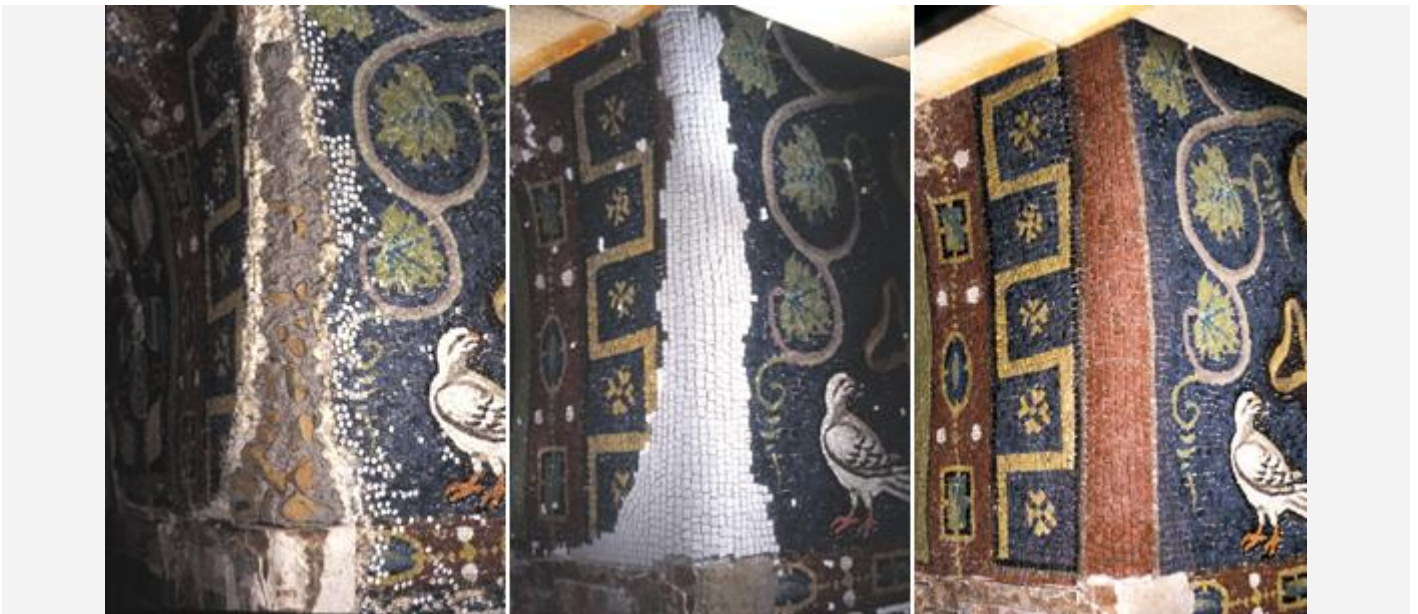
Three stages in the filling of the lacuna of the corner of the triforo on the left of the presbytery. Photo by Livia Alberti

To this end we made around eighty tiny copper moulds which reproduced the shapes and sizes of the most common tesserae used in San Vitale. These could then be used to impress the shape of the tesserae into the binder-rich mortar we used to fill the lacunae. The most difficult re-integrations were usually also the biggest. These were only carried out after the completion of a preliminary study which recorded the traces of preparatory painting and indentations in the old bedding mortar – indicative of the number and the alignment of the missing tesserae. The graphics 1 : 1 thus produced were used as a guide for the integration using the copper moulds.

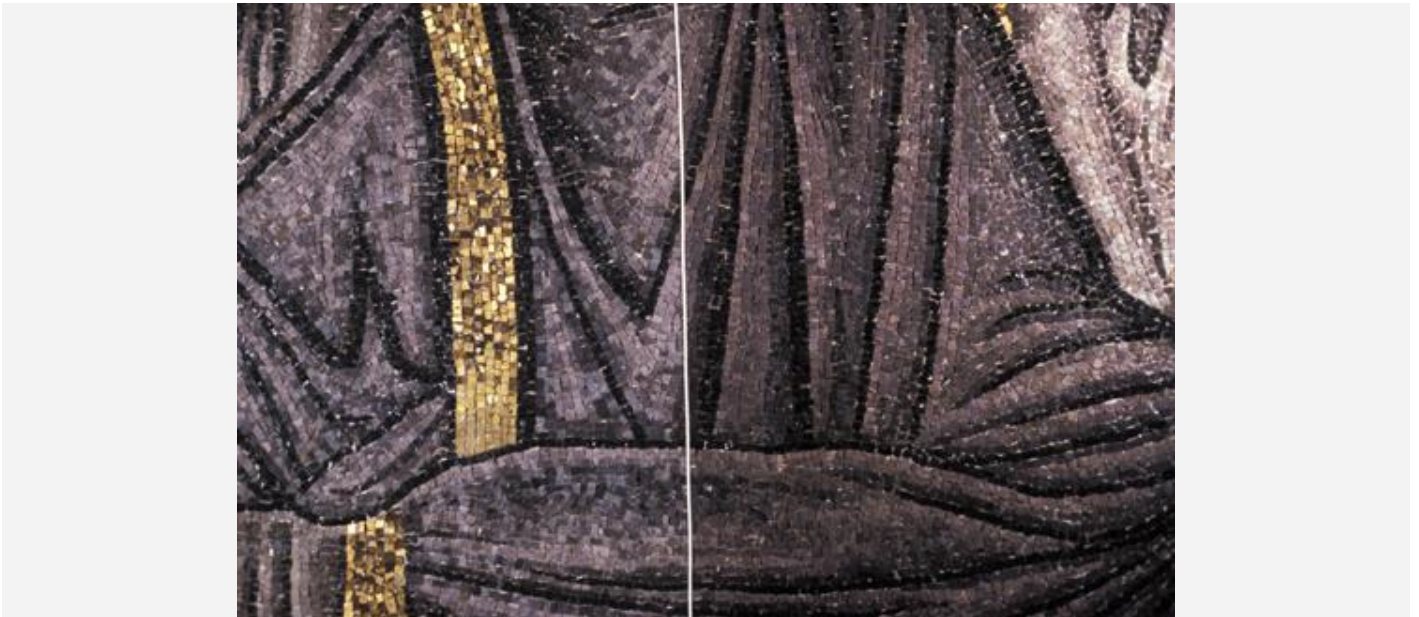
The theophany scene – Christ's robes before and after consolidation of the glass tesserae. Photo Livia Alberti *

Some damaged tesserae needed to be consolidated before cleaning could begin. Gold and silver tesserae, whose original protective layer of glass had been lost or damaged, had a protective layer of acrylic resin applied to them first. On the other hand, the damaged glass mosaic tesserae had to be cleaned first in order to facilitate the penetration of the silicate resin used to consolidate them. This product, by closing up all the fractures in the glass, gives a refractory quality to the tessera which is very close to the original and therefore restitutes its colour.

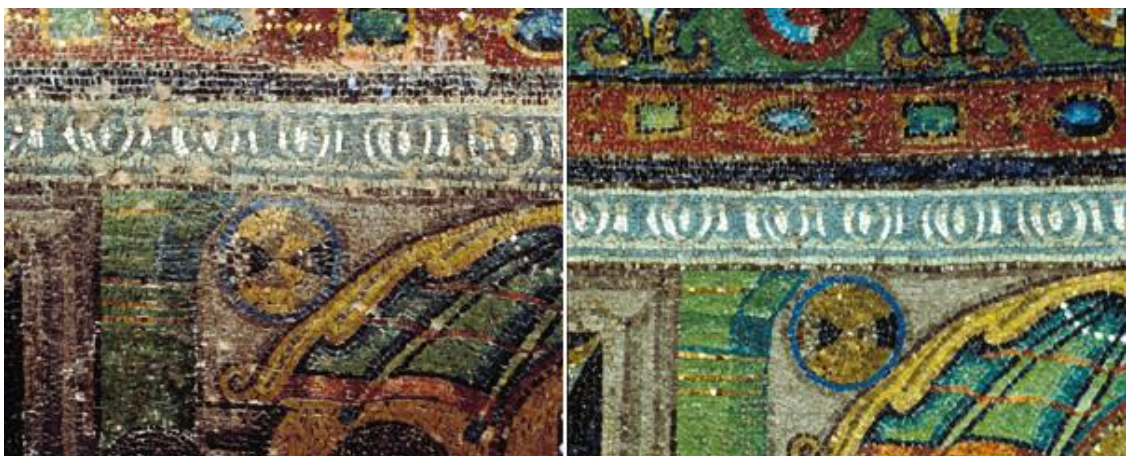
Right-hand panel in the apse showing the frame above the Empress Theodora – before and after cleaning with ammonium bicarbonate. Photo Livia Alberti *

To clean the mosaics we used paper pulp compresses soaked in ammonium bicarbonate spread onto 'Kleenex' paper tissues. This was done to prevent the paper pulp from going into the interstices between the tesserae which would have been difficult to remove. The compress was left on for periods varying from 15 to 45 minutes and then removed. The mosaics were then rinsed with water using a hand-held spray, taking great care to clean all five sides of each tessera. Any remaining surface deposits that had been resistant to the compress treatment were removed by hand, using scalpels, small chisels and glass fibre pencils.

Removing the layers of grime, salt deposits, old mortar repairs and previous pictorial restorations had the revelatory effect of returning the colours of the glass tesserae to their natural brilliance, bringing out the numerous variations in tone and contrast and restoring the beauty and vigour of the images. The ammonium carbonate left no residue on the surface of the mosaics as it dissolved into the air in the form of carbon dioxide, water and ammonia.

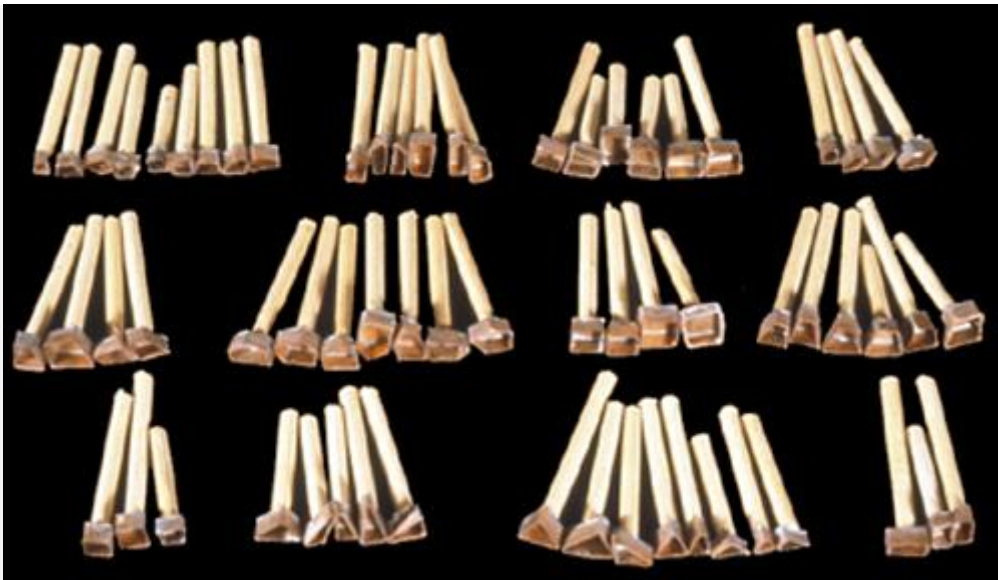
Copper moulds – Photo Livia Alberti *

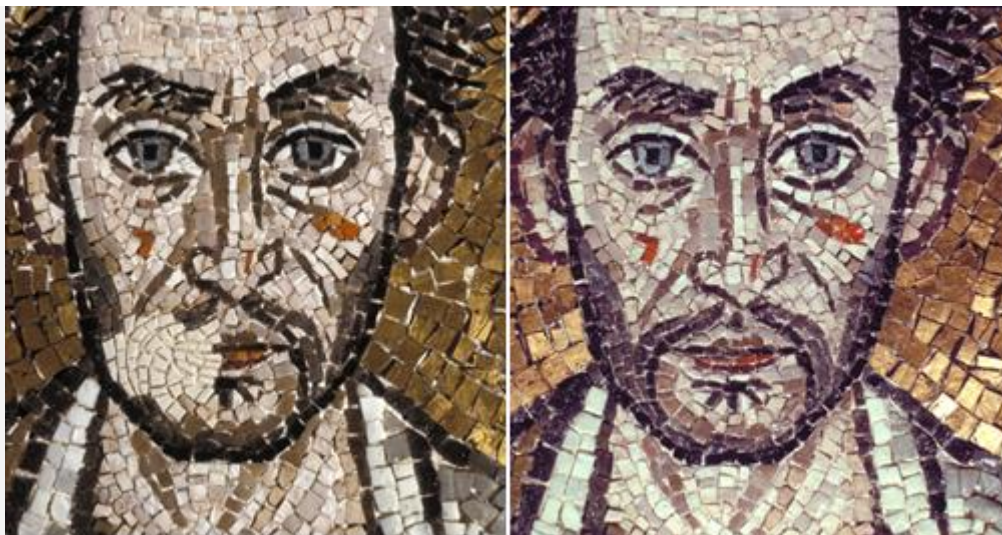
Head of Maximianus in the Justinian panel partially and fully restored. Photo Livia Alberti *
